Acton Scott Museum - 1943 Fordson Standard Tractor

A group of volunteers have restored a World War II Standard Fordson Tractor, which is owned by the Acton Scott Historic Farm Museum. This tractor is quite special because its first owner was Mr Jones of the Acton Scott Farm, the father of the current farmer, which is adjacent to the museum.

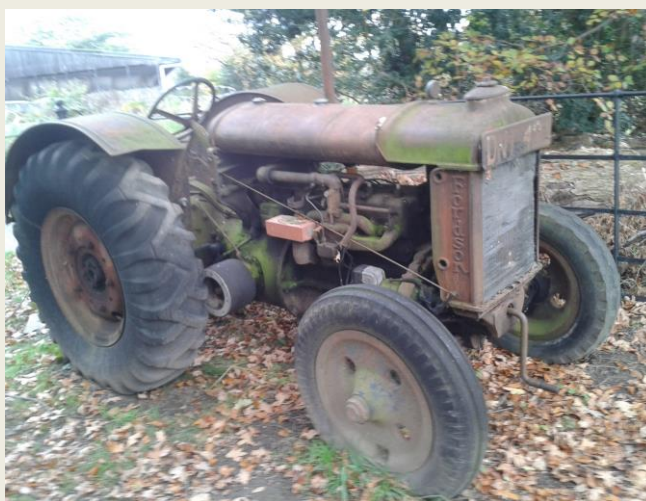
As can be seen in this picture, the tractor looked a little sad when it came to the museum, in need of sympathetic restoration.

A group of enthusiasts, who did not wish to see it deteriorate further, offered to help restore it to working condition.

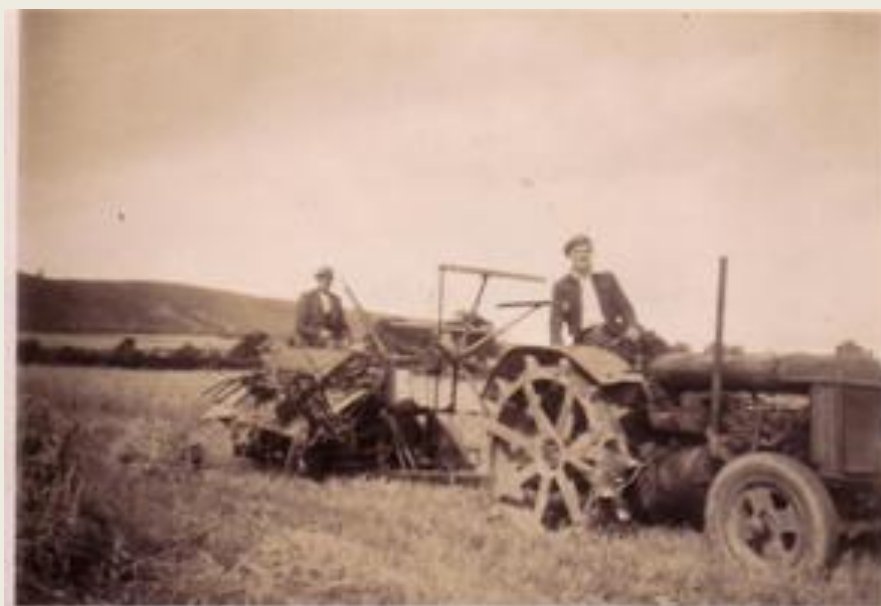
Mr E Jones has kindly supplied this photograph of the 1943 Standard Fordson pulling a binder for cutting corn, in his field just across the road from the museum. The tractor is being driven by Mr Jones' brother, and his father is sitting on the binder.

The photograph shows steel wheels fitted to the rear of the tractor, to give it more grip.

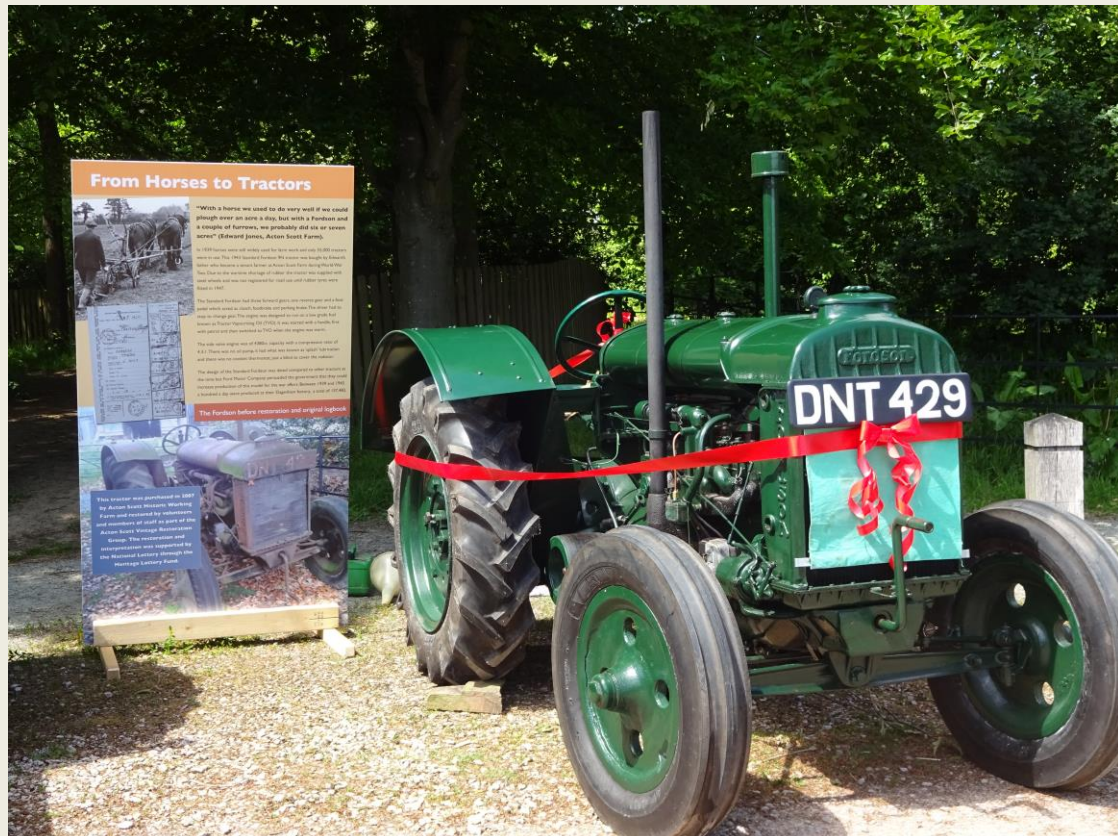
Here is the completed restoration, which was only possible thanks to help from the Heritage Lottery Fund which enabled things like the body panels, tyres and radiator to be replaced.

Since restoration the main problem has been getting it into gear, with horrible noises emanating from the gearbox! The clutch plates have been replaced and it was hoped that the 'dish' on the new plates would assist release. However it has still been troublesome and it has been deduced that there is insufficient 'drag' in the gearbox to cause the clutch plates to part. One problem is that the original specification of oil is not readily available. Eventually a VG140 gear oil was sourced, but is evidently not heavy enough.

During final stages of restoration and testing, the tractor was viewed with interest by a technical manager from [Corgin](#). In conversation with the restoration team, the subject of gear oil was discussed, and a kind offer was made by Corgin to donate 20 litres of a VG220 gear oil, as used in heavy equipment drive gearboxes, to help overcome the issues with gear change.
